Manhole Inspection Summary

Manhole # S35A__025MH

Inspection ☐ Is Incomplete Rating: **5) Immediate Attention Required**

Location Address: **401 GUILFORD AV**

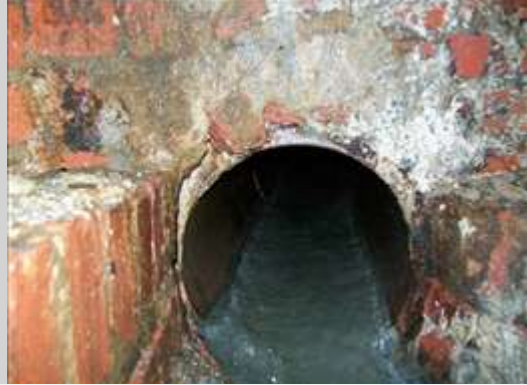
8 O'Clock Inflow

12 in. Circular Gravity Sewer
Pipe In @ 8 O'Clock

Pipe Height: **12** (in.) Rod and Bar (Angled)

Pipe Material: **Clay** ☐ Pipe Lined

Infiltration: **None** Pipe Seal Cond: **Sound**
